1969 CORVETTE STINGRAY L89

CONVERTIBLE
19467S704504

Used Vehicle Appraisal

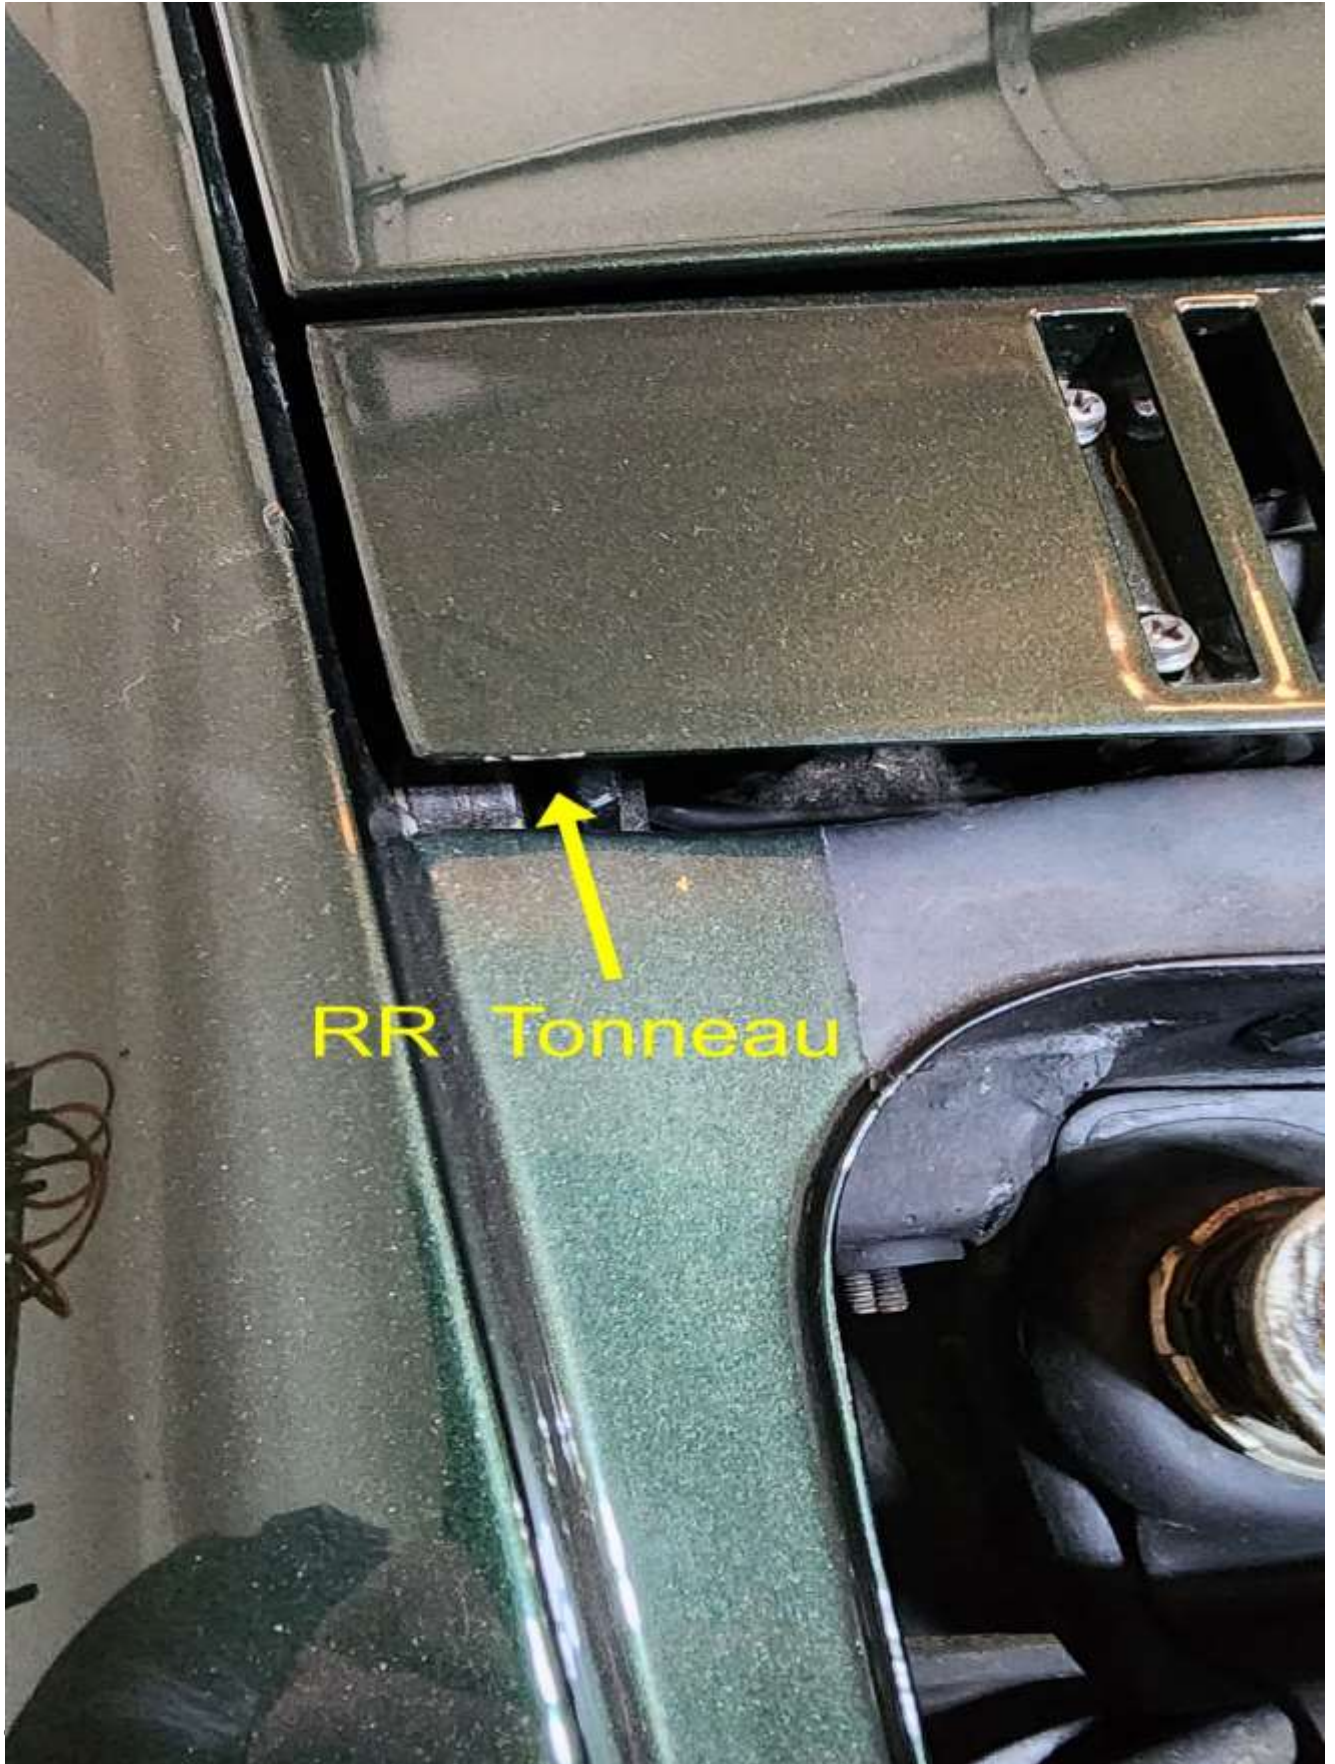
RR Tonneau

The convertible top is in near new condition with no scratches on the rear window. The right side lock tab in the rear is difficult to release. This is due to the tension rod having excessive pressure on it. The fulcrum in the center appears to be assembled incorrectly and reversed. The
