1987 VOLKSWAGEN VANAGON GL SYNCHRO

WV2YB0259HG014909

Used Vehicle Appraisal

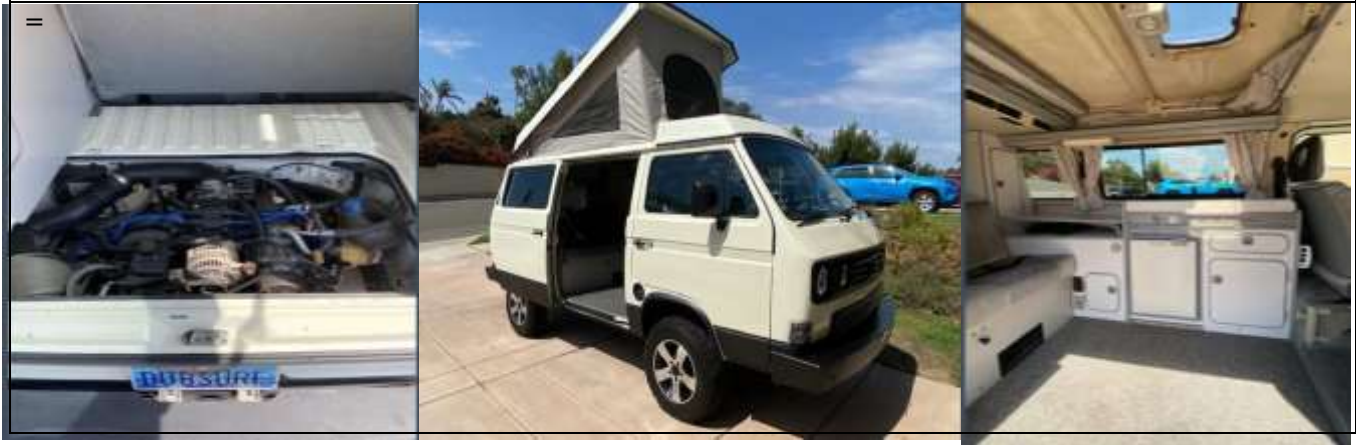
Year:	1989	Mileage:	5,086	Location:	Los Angeles	Date:	06/05/2023
Grade:	1	Asking:	\$95,000	Sale Type:	Private Party	Sold:	Available

Comments: 1989 Westfalia, documented #1 restoration with 5,806 miles, includes warranty. 2WD with factory rebuilt engine. Every nut and bolt new. Were it a Synchro, it would likely increase 25% in value.

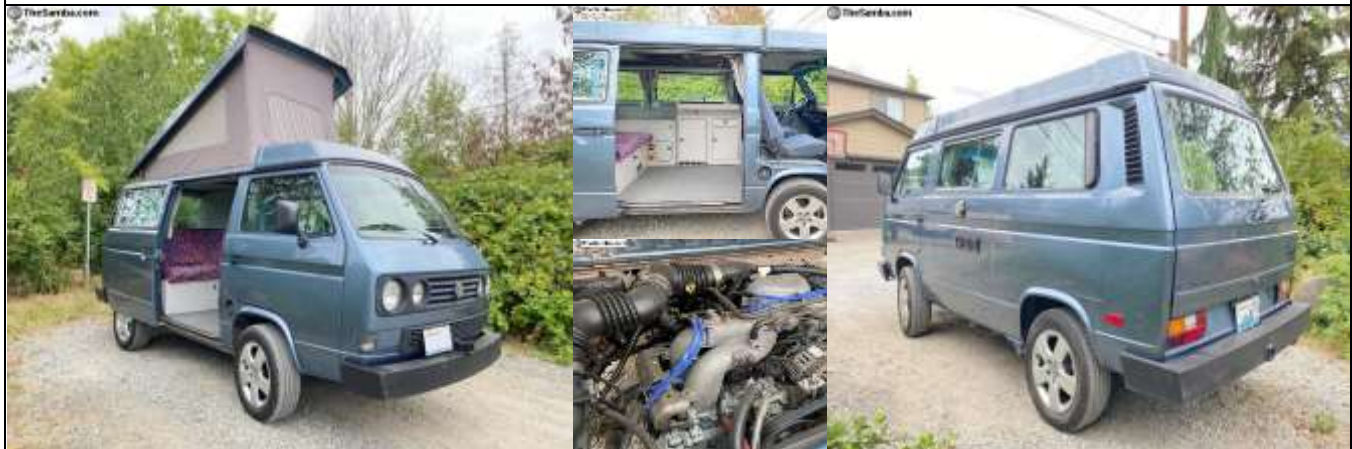
Year:	1986	Mileage:	217,080	Location:	Seattle	Date:	06/30/2023
Grade:	3	Asking:	\$39,000	Sale Type:	Private Party	Sold:	Available

Comments: Westfalia in good condition. Subaru conversion engine is relatively new. Newer paint rebuilt automatic transmission, much restored. Has some evidence of damage over the rear fender noted by cracked body filler and bubbling paint indicating improper rust repair.

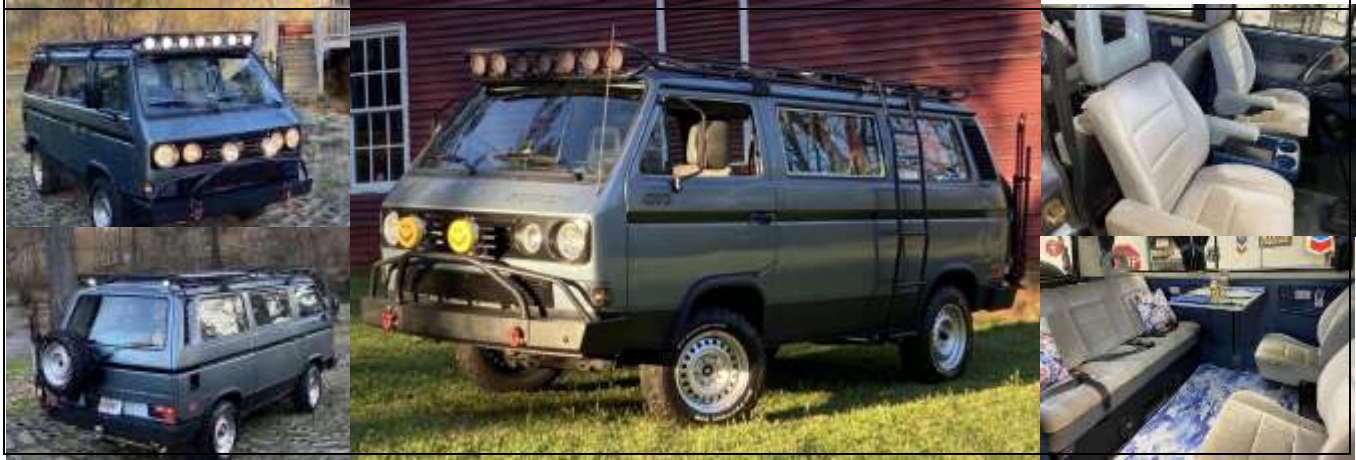
Year:	1987	Mileage:	Unknown	Location:	Georgia	Date:	04/20/2023
Grade:	3	Asking:	-	Sale Type:	Private Party	Sold:	\$28,000

Comments: Customized 1987 GL Synchro. Subaru Engine, 5 speed. Converted into 'Weekend Trim' In fair to good condition, has some body damage from off road use. Middle of the #3 grade. Daily use vehicle. Somewhat Unique. Mileage unknown.

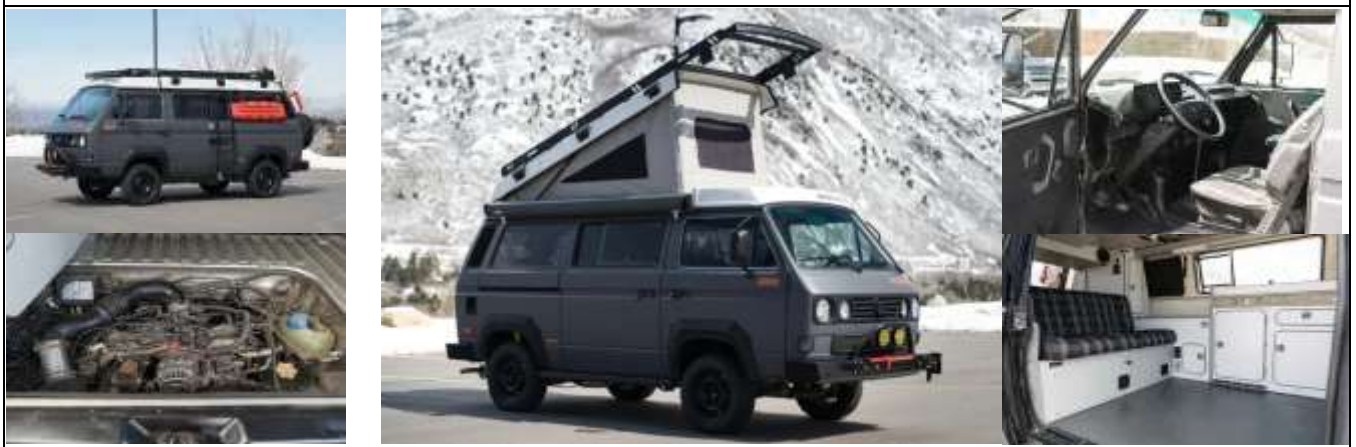
Year:	1987	Mileage:	170,000	Location:	Utah	Date:	04/1/2023
Grade:	2	Asking:	-	Sale Type:	Private Party	Sold:	\$51,500

Comments: 1987 GL Westfalia with Subaru and 5 Speed conversion. Very good condition with some unique and nostalgic add-ons. Fully equipped Camper van.

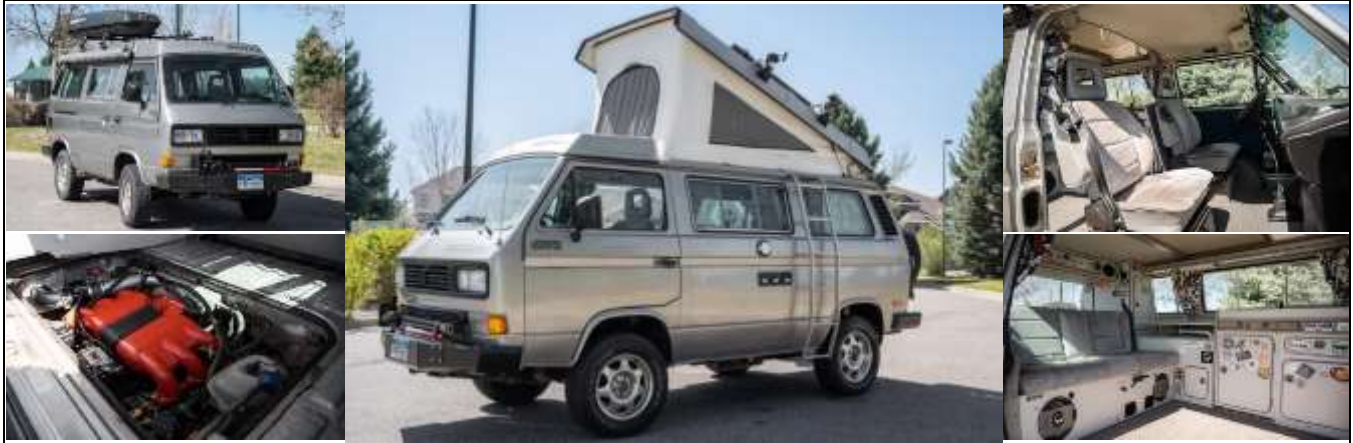
Year:	1987	Mileage:	243,000	Location:	Denver	Date:	05/24/2023
Grade:	3	Asking:	Auction Bid	Sale Type:	Private Party	Not Sold:	\$40,000

Comments: 1987 Subaru Conversion w/ spare engine. High Mileage. Significant Maintenance listed. Some interior and canopy stains, other evidence of wear. Otherwise in good condition suitable for regular use. High bid of \$40,000.

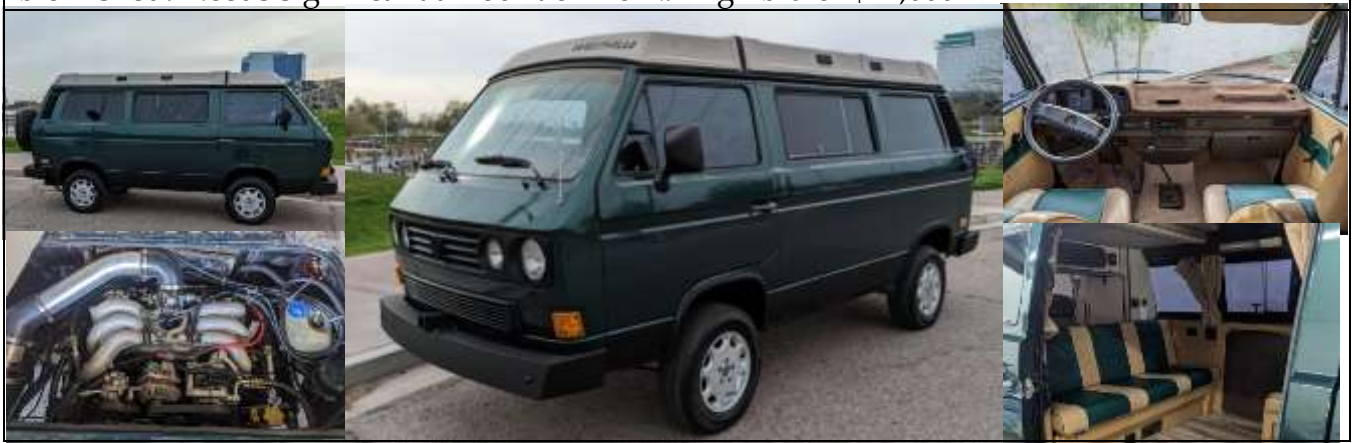
Year:	1986	Mileage:	151,000	Location:	Arizona	Date:	06/01/2023
Grade:	4	Asking:	Auction Bid	Sale Type:	Private Party	Not sold:	\$17,000

Comments: 1987 Synchro Subaru conversion. Originally East coast car. Fully equipped. A/C non-operable, damaged dash, steering column, ignition, mileage in question, side door issues, cracked top. Rust lifting through repaint throughout on seams, paint peeling and blemished. Needs significant amount of work. High bid of \$17,000
