1962 Fiat 1500S OSCA

A True Italian!

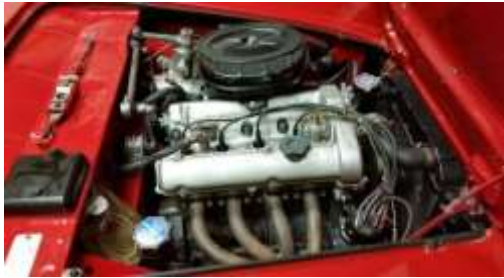
1962 Fiat 1500 OSCA Engine

As a 1960's car, of course they are very mechanical, the OSCA version not so much as the 1200. The Maserati engine, heavier suspension, deluxe interior and sports car instrumentation were far more refined than the 1200. The OSCA was much more of a pure Italian convertible than most Italian cars of it's day, barring Ferrari and other exotics. It was the next best thing. The Fiat OSCA, as well as many other exotic Italian cars of the era were hand assembled Pininfarina's.

The OSCA engine was a 1497cc twin cam engine was designed by Maserati and produced by Fiat, while the 4 speed transmission and rear differential were essentially unchanged from the 1200 (with the exception of the bell housing and clutch) throughout the range until the 5 speed was introduced in 1964. They received upgraded dual cylinder hydraulic drum brakes for 1959-61. Both disc and drum brake models were fitted with an inline proportioning valve unique to this model along with a hydraulic clutch. Both required a good degree of technical skill to adjust and still do. The drum brakes in the front were somewhat complicated having 4 adjustors at each wheel. Proper service required machining the arc of the shoes to the drums and measuring clearance around the diameter of the drum through holes cast around the circumference. The drums are often stamped with the location on the car, such as LF etc.

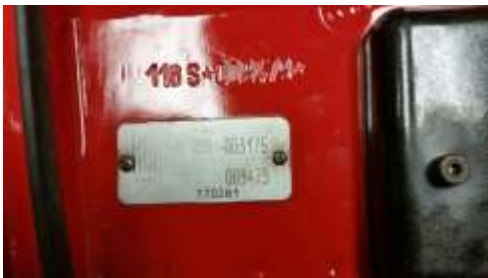
VIN Tag and stamping 1500S

As with Ferrari, the 1500 OSCA had numbered pieces, such as door handles, bumper over riders and various other trim pieces. The parts were pre numbered to go with each car before assembly. What happens after that, only the assembler knows. Typically, the tags welded to the underside of the hood and deck lid will match the last three of the build number stamped on the left rear of the trunk floor. The first two numbers indicate the model designation. 38 or 39 for OSCA, 58 or 59 for 1200. No exceptions

The engine serial number is stamped on the VIN tag located at the right rear of the engine compartment along with the paint code from '59 to '61. Many of the '62 tags completely omit the engine number. It is also not at all uncommon to find a mismatched engine number, or even a 1600 118SA engine in a 1500S depending on when it was produced. There are well documented cars with the original engine and the wrong number. The VIN will always begin with 118S for OSCA. The OSCA engines are numbered 118, 118SA, 118SB.

The number sequence on the VIN tag appears to be somewhat irrelevant. An unrestored '59 1500 OSCA (not an S) with engine number 0335 was found to be first registered as a '62 upon State Patrol inspection. It could be the import date or the date it left the factory. Another 1962 1500S model with no engine

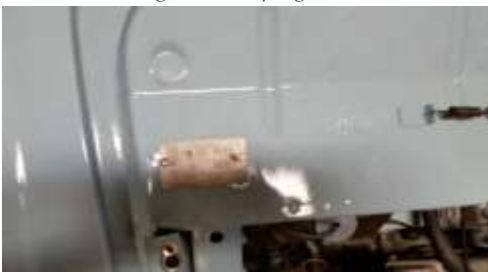
1960 Fiat 1500 (Note the fuse box and location))

Fuse boxes were mounted inside the passenger foot well from 1959 through most of 1961 when it was then moved to the engine compartment next to the VIN tag. Column switches were a metal canister type through 1961, regardless of model including 4-wheel disc cars.

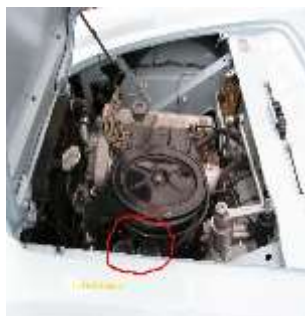
1960 Drum Car

The defining features of the very rare 1961 4-wheel disc car is the use of two separate license lights, wider headlight ring and the two metal brake fluid reservoirs as earlier cars would have. Aside from having two reservoirs, the location of them also helped to identify the year. Drum cars had both mounted near the carburetor while 4 disc cars had one on each side of the engine compartment. The 1962 models had a plastic reservoir for the brake fluid making them easily distinguishable upon opening the hood. The plastic reservoir on a disc brake car is far more common and reveals the '62 model quite clearly.

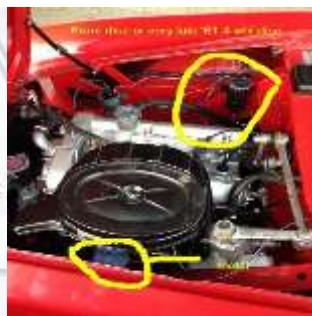
1961 2 or 4-Wheel Disc

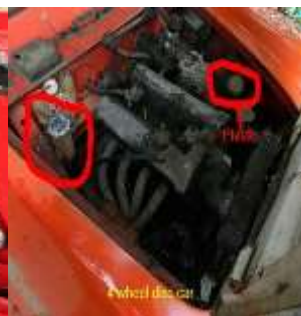
4-Wheel Disc Car

In 1962, the OSCA was upgraded to 4-wheel disc as standard. There are however many examples that have only front disc for 1961 and 1962 both. There is no distinction between them visually aside from the plastic brake fluid reservoir for '62. '61 front disc car reservoirs would be metal. These were likely left over rear drum set ups from earlier years and intended to be 4 disc cars.

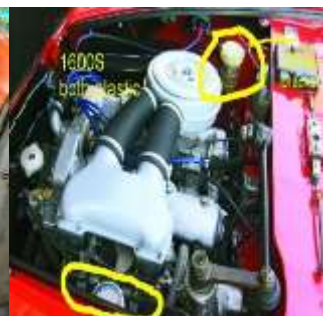
1600S Power 4 Disc

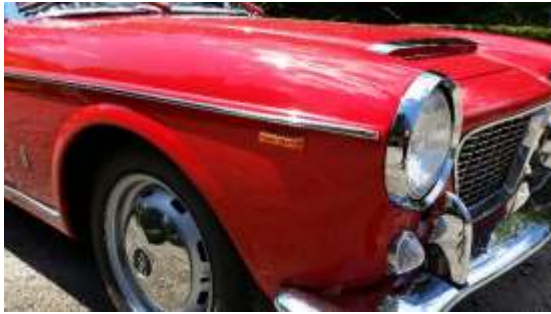
1500S Front Trim

There are a handful of other features depending on the build date. For example, in '62, 64 and '65 the front markers were concave instead of the beehive style. The 1963 118SA models had beehives, a 1600 engine with a twin 36 Weber, side hood scoop and four speed transmission. These were built for only about six months. This was the only model designated for an offset hood scoop, although some of the hoods made their way onto the 1600S in '64.

European models had small fender mounted side repeaters and amber rear signal lamps while U.S. cars had red lenses and no repeater. The '62 also had an extra chrome strip on the hood underneath the larger hood chrome and a wide one-piece license lamp. All OSCA's had a two piece Pininfarina emblem located between the front wheel arch and the door.

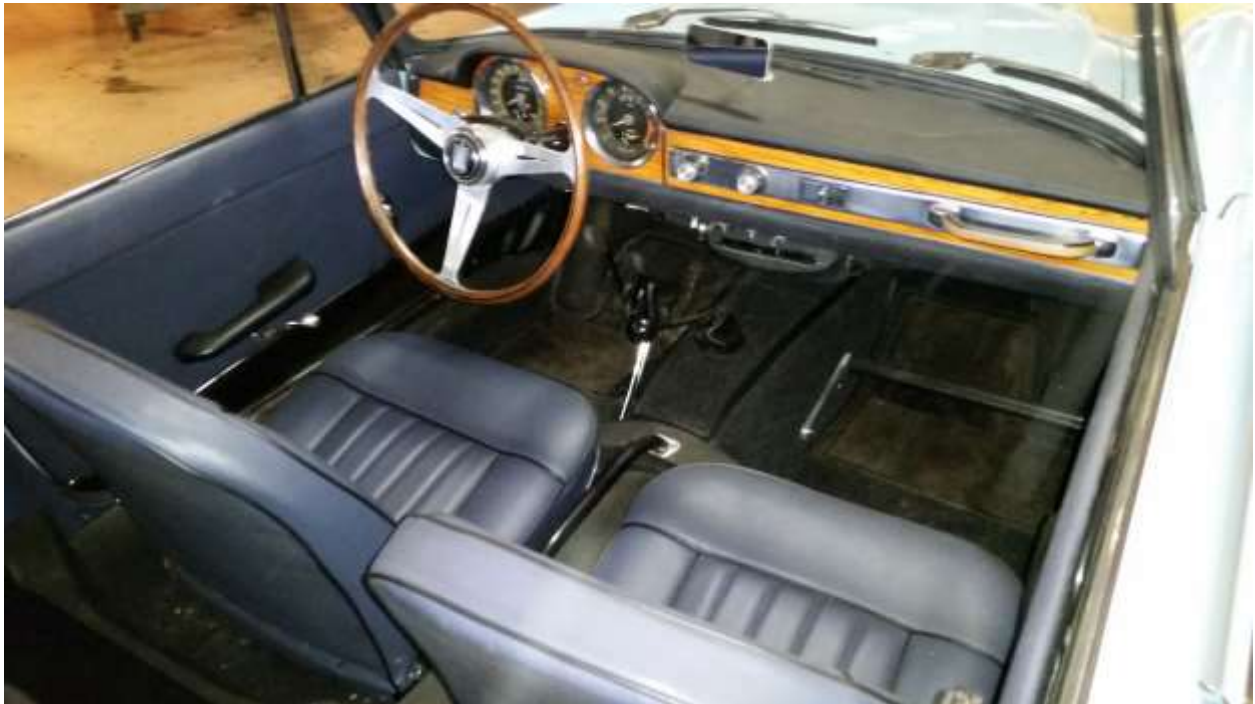
1960 OSCA Interior

Interior appointments varied slightly but not much. Early models had two tone seats in either red/black or white/black combinations. The door panels were coordinated and had lower trim with a kick plate which is often missing. All of the cabriolets through 1961 had two tone door panels originally with rubber mats complimented by removable carpets with integral rubber mats and a carpeted transmission hump. Most mid 1961 and later models had solid colored seats with a different stitching pattern. OSCA models had a thin silver plastic trim fit around the lower edge of the seat. Seat adjusting levers were usually located on the body rail, although in '62 the seat adjusting lever moved to the seat bottom.

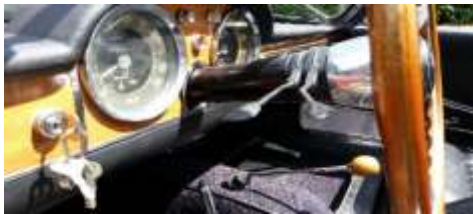
In '62, a plastic switch that fit like a sleeve over the column was introduced only to be replaced in late 1963 with a different column. Some cars had bumper mounted driving lights, likely dealer installed.

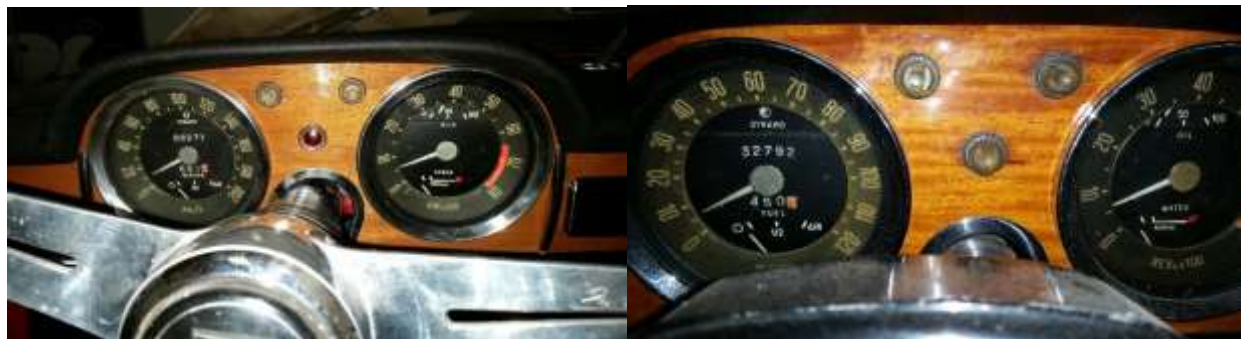
European Model

U.S. Cars

The featured car was found in Seattle Washington with some restoration work completed. Previous owners purchased it from a long-time friend that imported the OSCA after a European assignment. It is titled as a 1961, although it is actually a '62 based on the trim and other features. It is also a European model, partially evidenced by the speedometer and gauges.

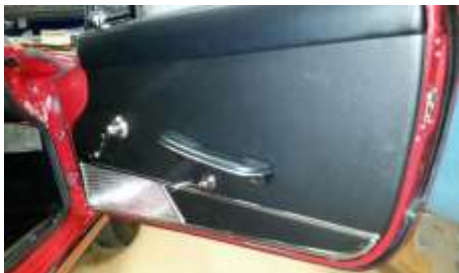
1959-62 door panel

New rubber floor mats and custom made factory style carpet was fitted and installed. The seats and door panels were custom made in Italy and the correct door panel trim was polished and installed along with new OE arm rests. The panels were done in black to compliment the black interior, a slight but worthwhile deviation. The new dash wood was fashioned by hand, replicating the original look flawlessly.
